Subject: Revised Final Biological Construction Monitoring and Impact Assessment Report for the Bolsa Chica Roadway Embankment Reconstruction Project;  
Coastal Development Permit Emergency Permit No. 5-09-131-G;  
United States Army Corps of Engineers Emergency Permit (No. SPL-2009-00531-SCH);  
United States Fish and Wildlife Service Informal Section 7 Consultation,  
FWS-OR-09B0048-09F1004;  
Request by NOAA's NMFS (email dated July 15, 2009)

*SR-1 Bolsa Chica Roadway Embankment  
Reconstruction Project*

Pre-and Postconstruction Photos

*SR-1 Bolsa Chica Roadway Embankment  
Reconstruction Project*  
Potential Corps/CCC Jurisdiction  
and Proposed Impacts  
12-Ora-1  
PM 28.7-29.7  
EA 0K0100

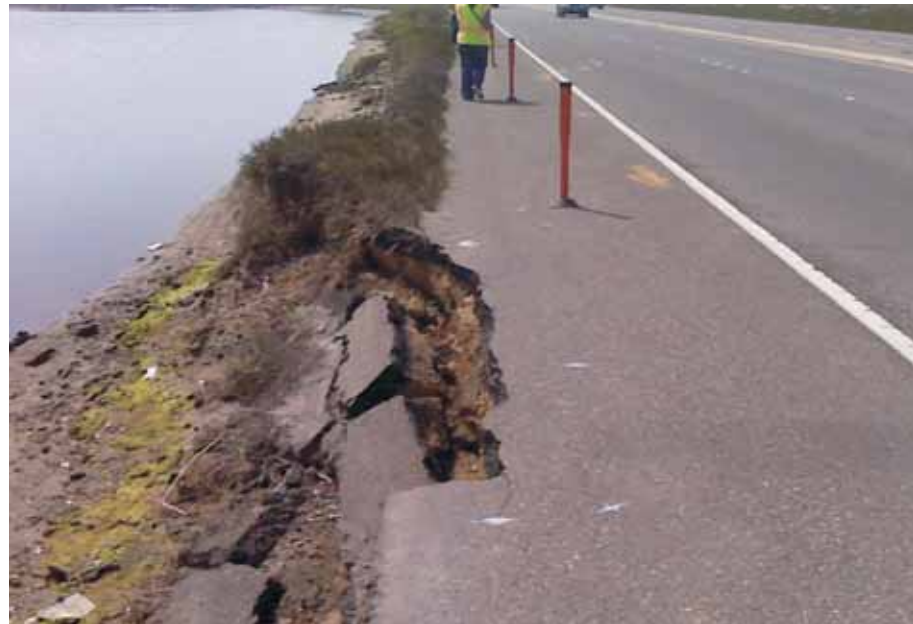
**Preconstruction:** View of eroding pavement along the road to the east of SR-1, facing south (07.14.09)

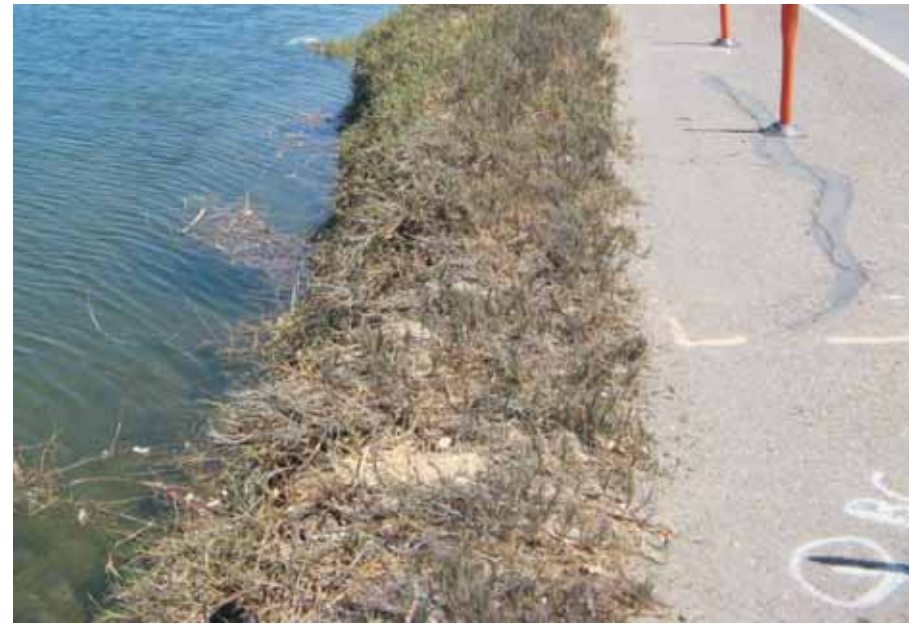
**Preconstruction:** View of SR-1 shoulder, facing south; estuarine wetland vegetation to be removed (07.27.09).

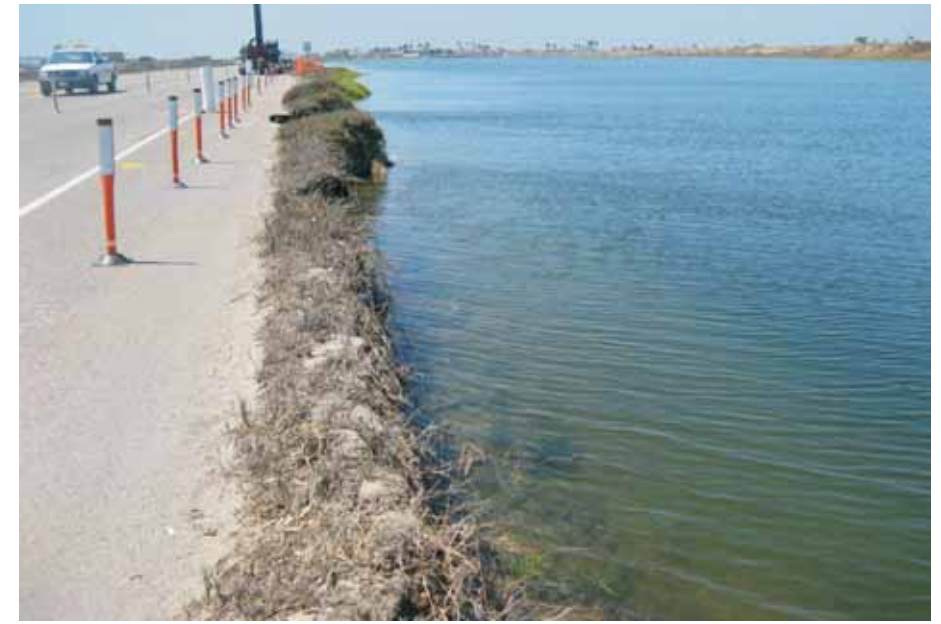
**Preconstruction:** View of SR-1 shoulder, facing north; estuarine wetland vegetation to be removed (07.27.09).

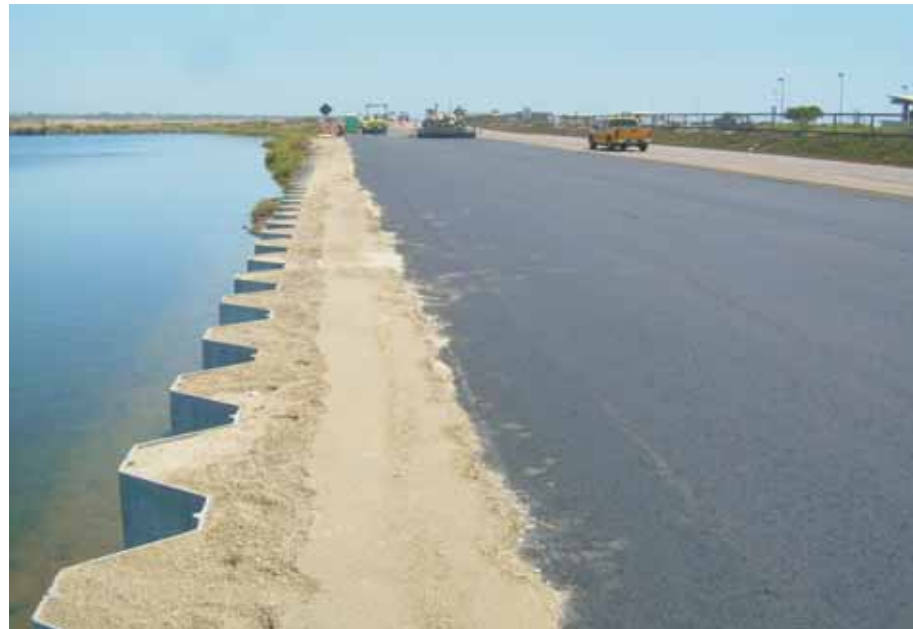
**Postconstruction:** View of SR-1 shoulder, facing south, after installation of sheet piling and associated back-fill (08.11.09).

Project construction occurred between July 27, 2009, and August 7, 2009, from approximately 6:00 a.m. to 6:00 p.m. during weekdays only. Initial project activities included potholing for utility verification and installation of detour signs. Between July 28 and July 31, 475 feet (ft) of sheet piling was installed to 30 ft in depth, approximately 5 ft from the edge of the asphalt shoulder. Sheet piles were then trimmed and backfilled with sand to a level equal to existing shoulder elevations. During the second week of construction, final trimming and backfilling occurred. The damaged shoulder of the road was then removed and paved.

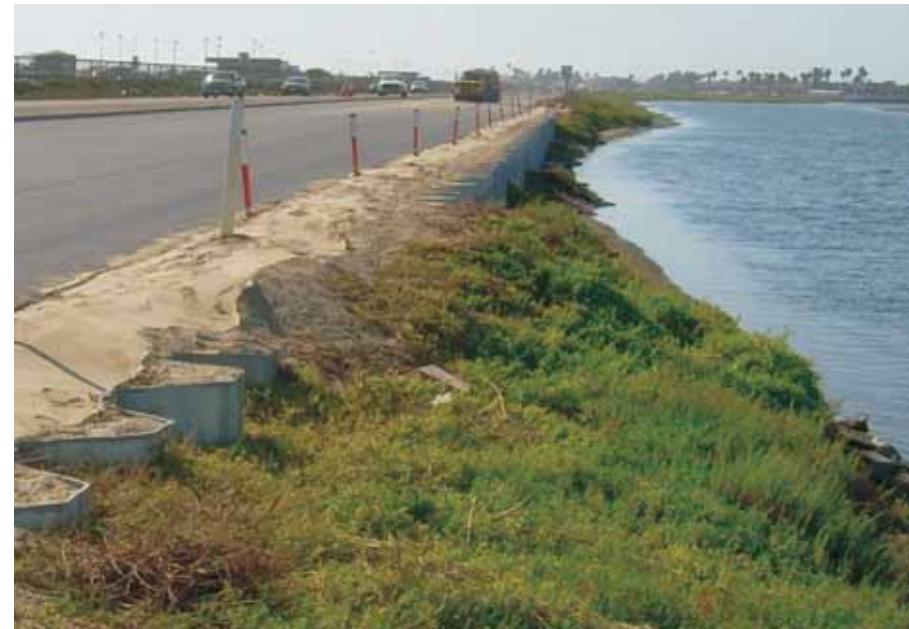
**Postconstruction:** View of SR-1 shoulder, facing north, after installation of sheet piling and associated back fill (08.11.09).

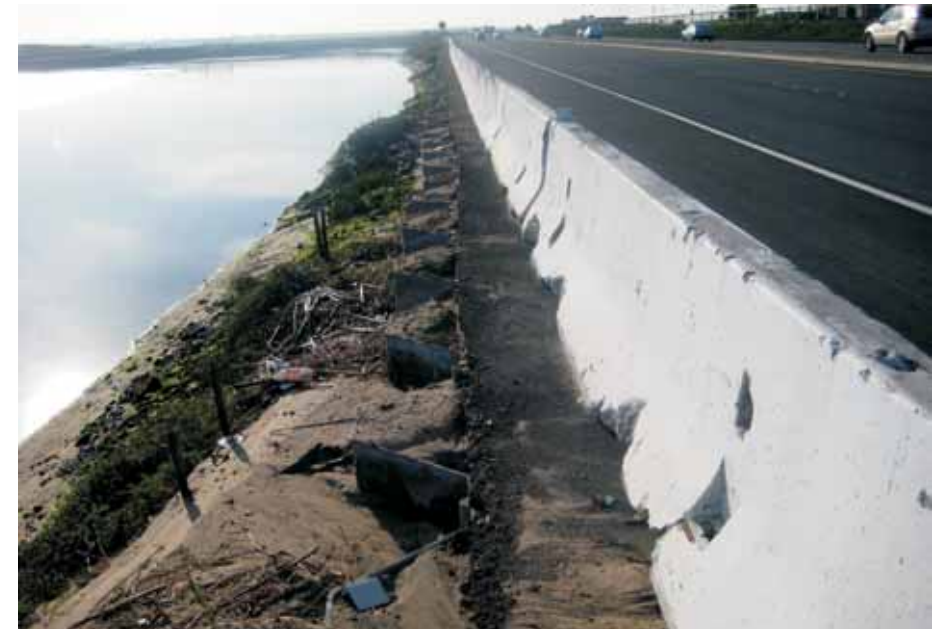
**Postconstruction:** View of SR-1 shoulder, facing south, after installation of temporary K-rail (03.05.10).

Following completion of sheet pile installation, a temporary K-rail was installed on August 21, 2009, in order to bring SR-1 into compliance with Caltrans safety specifications. Fill (i.e., sand) was displaced during installation activities and then removed manually with shovels from adjacent areas of vegetation in the presence of a biological monitor on August 26, 2009. The temporary K-rail will ultimately be removed and replaced with a metal-beam guardrail. Installation of the metal-beam guardrail is not a part of the emergency project and will be addressed under separate permits.

- Following completion of the emergency project, a temporary K-rail was installed on August 21, 2009, in order to bring SR-1 into compliance with Caltrans safety specifications. The temporary K-rail will ultimately be removed and replaced with a metal-beam guardrail. Installation of the metal-beam guardrail is not a part of the emergency project and will be addressed under separate permits.

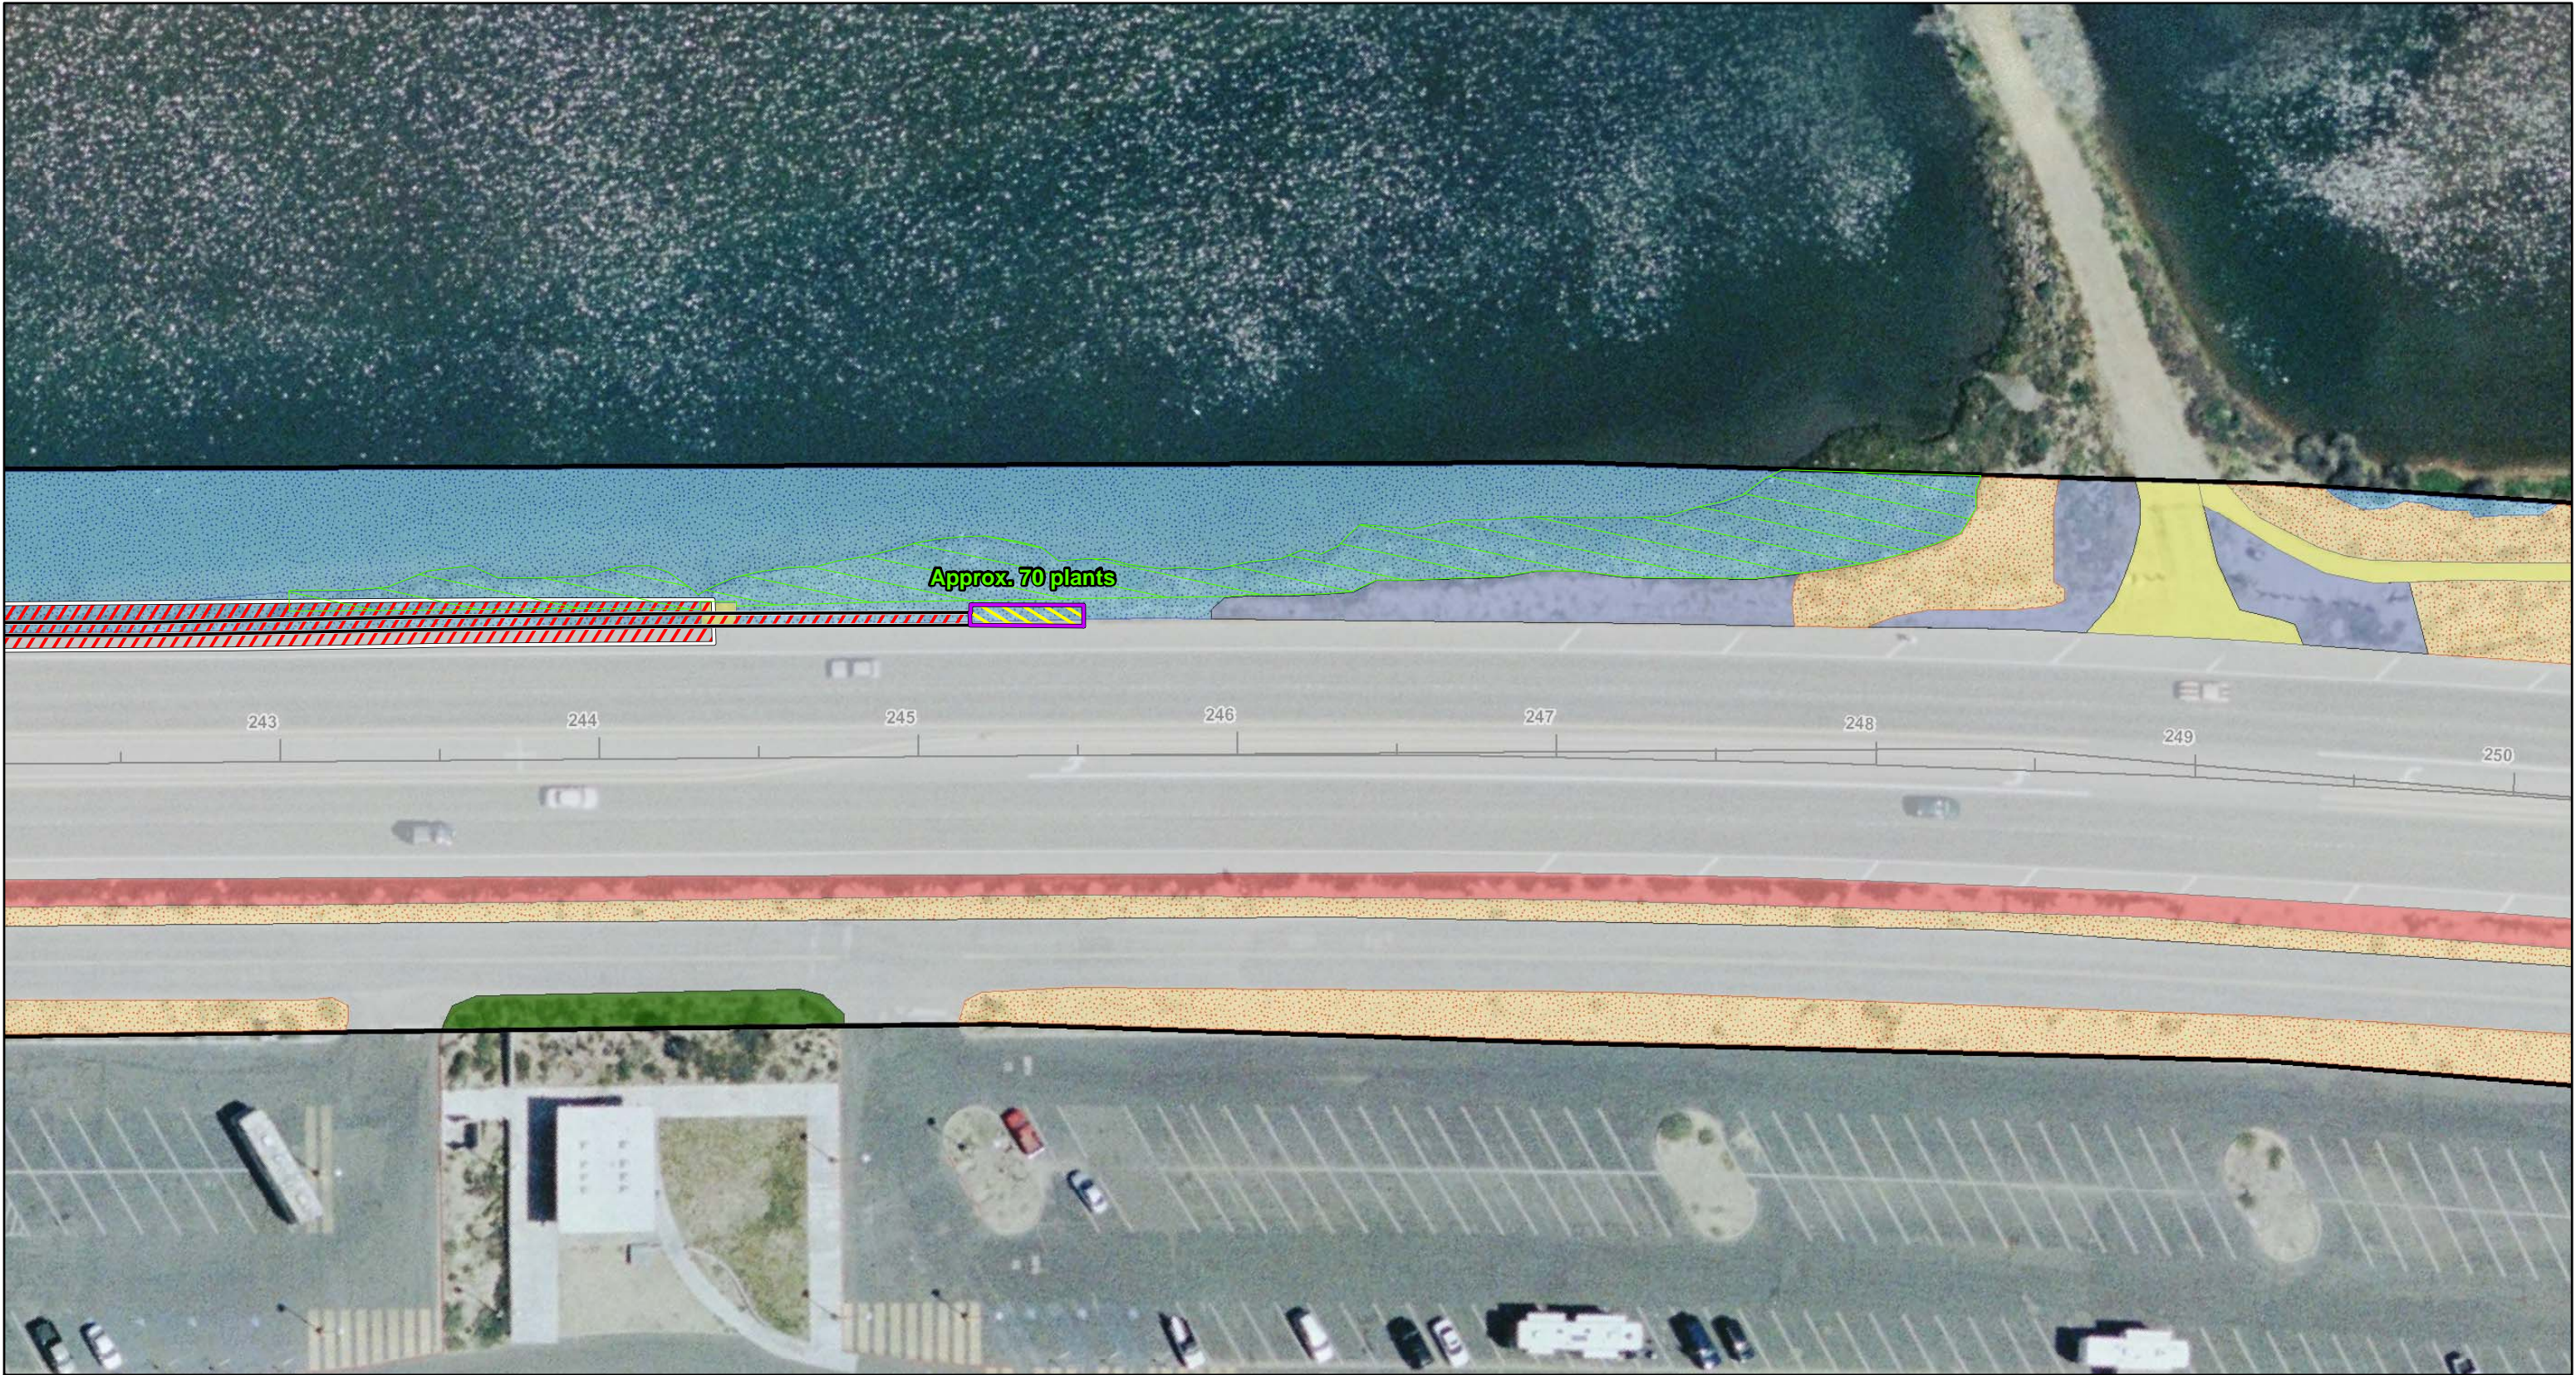
FIGURE 5  
Sheet 6 of 11

SR-1 Bolsa Chica Roadway Embankment  
Reconstruction Project  
Vegetation Map and Proposed Impacts

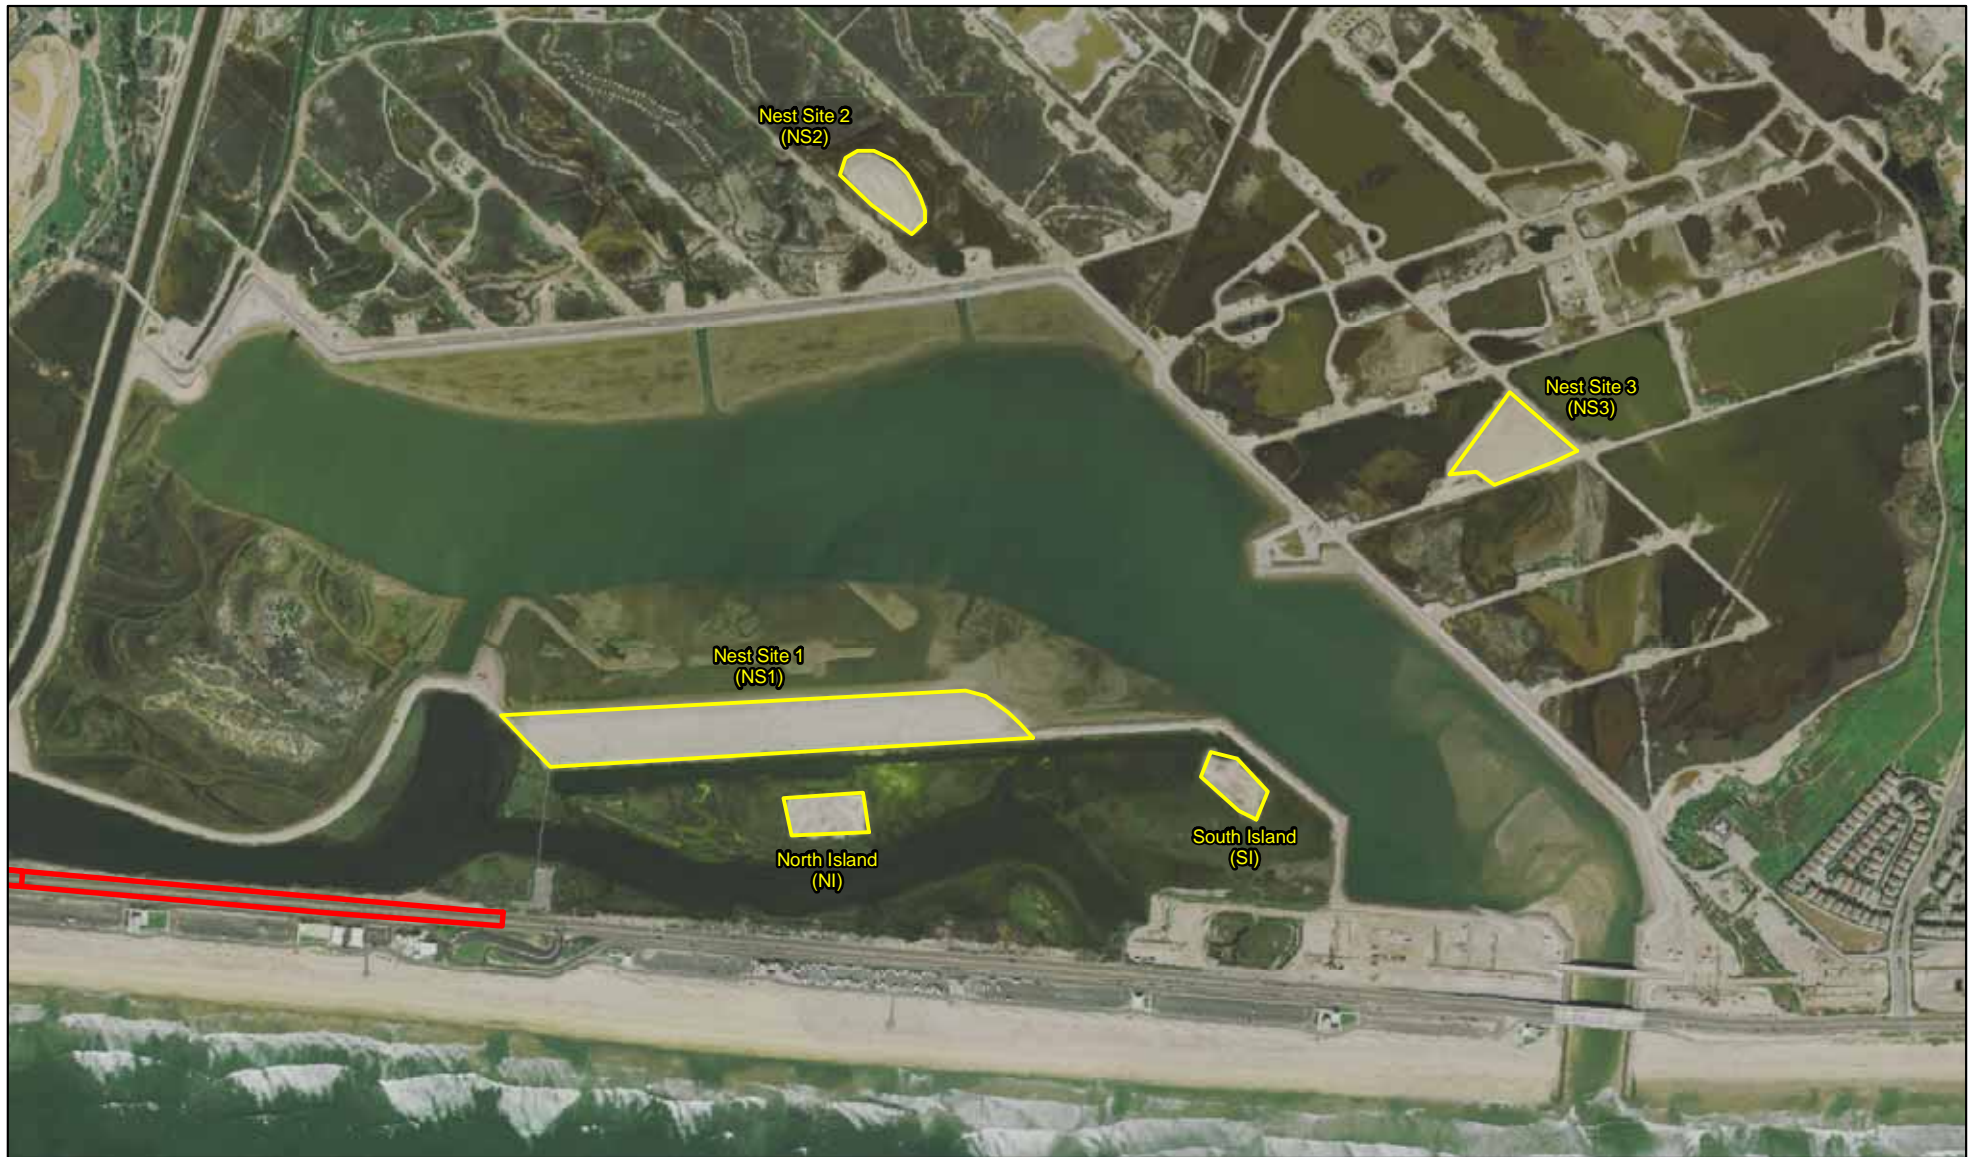
FIGURE 8

CNDDDB Sensitive Animal Species

Nine special-status animal species have the potential to occur in the BSA where suitable habitat is present (burrowing owl, brandt, western snowy plover, California black rail, Belding's Savannah sparrow, California brown pelican, light-footed clapper rail, black skimmer, and California least tern). Five of these nine species (Belding's savannah sparrow, California brown pelican, light-footed clapper rail, black skimmer, and California least tern) were observed in either the BSA or WSA during preconstruction surveys. Figure 8 shows several nesting site occurrences within the near vicinity of the BSA.
